# 3.0 Reliance No. 3 and Lionkol Main Pits: Design Summary

The AML Project 17H-2B-II, Reliance No. 3 and Lionkol Main Pits reclamation area addressed two separate coal mine areas primarily using NR design software with a minimal amount of traditional reclamation techniques. The project areas are shown in Figure A-1.2 in Appendix A1.

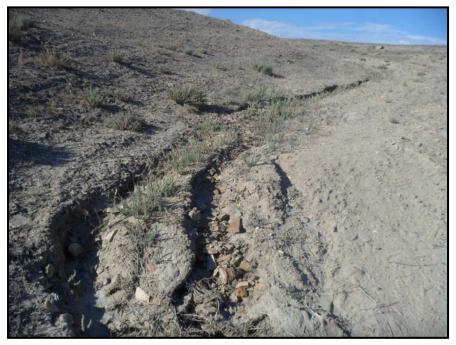
Figure 17: Reliance No. 3 North Spoils Main Failure: Channel cutting through point bar

The largest failure requiring repair was along the main channel of the North Spoils (see as-built drawing in Appendix A3.2). The channel was incised between 6 and 18 inches in depth along its length, and had several meander bends completely shortcut by pilot channel formation. Following unusually high precipitation in October 2013, some of the channels cutting through the meander bends of the channel had self-repaired. However, since the channel was designed with high Shields shear stresses (1.68-2.34psf at bank-full and 2.56-3.56psf at flood-prone) and that the erosion in the remainder of the channel had not self-corrected, the entire channel needed to be widened to prevent continued focusing of flow in the pilot channel. As such, the channel was repaired on October 29<sup>th</sup>, 2013 using a dozer to widen and reinforce the channel.

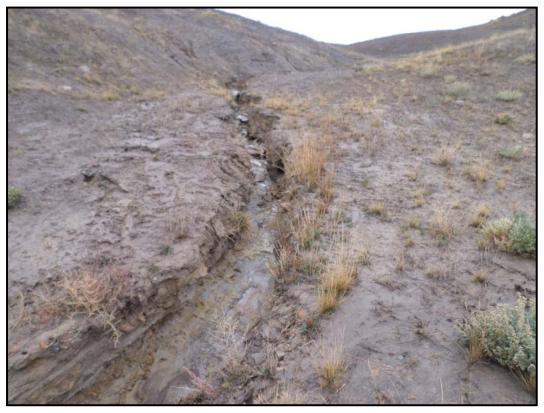
Figure 19: Lionkol North Main: Channel failure incised to bedrock

Failures within the Northwest 1 and Northeast 4 channels were less than 100 feet in length and between 12 and 18 inches in depth, requiring simple reinforcement repairs with a dozer and/or a scraper. The North Main channel had become completely incised exposing bedrock between 18

and 36 inches in depth by October of 2013. Although the channel was hard-pointing on bedrock, and would eventually have corrected itself, the process would have required many years and would have resulted in unacceptable amounts of sediment being transported downstream. As a result, the channel was widened utilizing an excavator, maintaining the incised flow-line elevation for the entirety of its length. The increase in cross sectional flow area is expected to drop the flow energy within the channel and prevent unacceptable levels of continued erosion. In addition, the ditch on the south side of the road into which the channel drained was reinforced with the excavator.

The erosion of the North Main channel resulted from several factors. In addition to having high gradients and the largest basin area in excess of 13 acres, the west facing slope of the North Main channel had the poorest re-vegetative success covering a widespread area of any Lionkol reclamation area. The lack of vegetation and lack of infiltration of rainwater into the poor soil of the slope increased runoff and caused unacceptable erosion within the main drainage. To mitigate this problem, multiple hummocks and swales were constructed on the slope utilizing a dozer to trap runoff, promote moisture retention and future vegetative growth.
