4.0 AML 17H-2B-III Lionkol Drainage Reclamation Project

5.0 AML 17H-2B-IV Lionkol West Drainage Reclamation Project

LIONKOL AREA GEOMORPHIC RECLAMATION
AML PROJECT 17 H-2, 2B-II, 2B-III, & 2B-IV
SWEETWATER COUNTY WYOMING

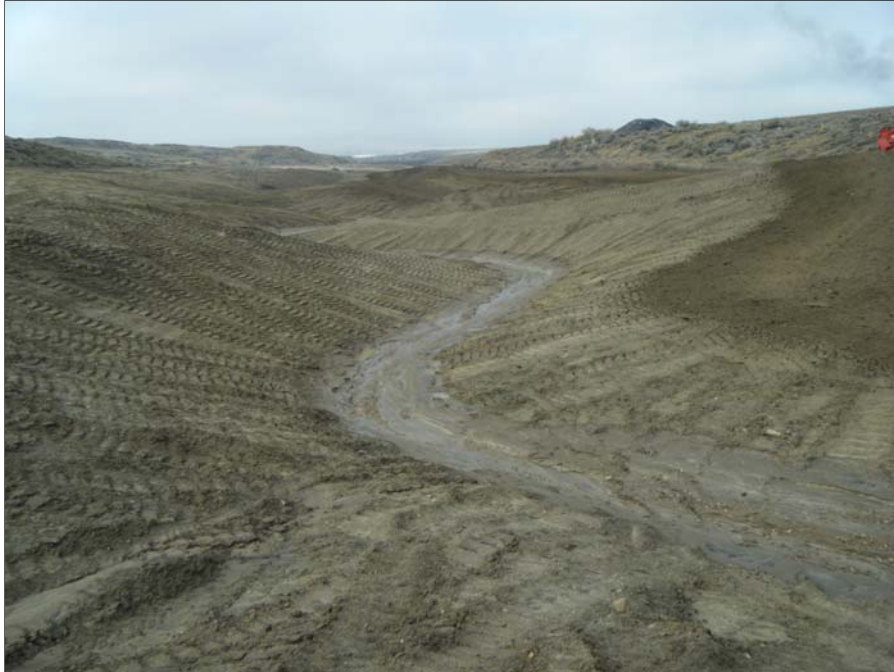
The main channels in both the upper and lower portions of the drainage performed well even during the unseasonably large rainfall experienced in September and October 2013. Their performance was very similar to the performance of other geomorphic channels including the Reliance No.11 channels (see Section 2.2.6 for channel performance summary). Only sparse vegetation has been observed to have taken hold in either drainage, a majority being cheat grass and other weed species. However, the area only had a single growing season to revegetate at the time of the observation.

Figure 22: Freshly Constructed Lionkol Channel Following High Runoff Flows

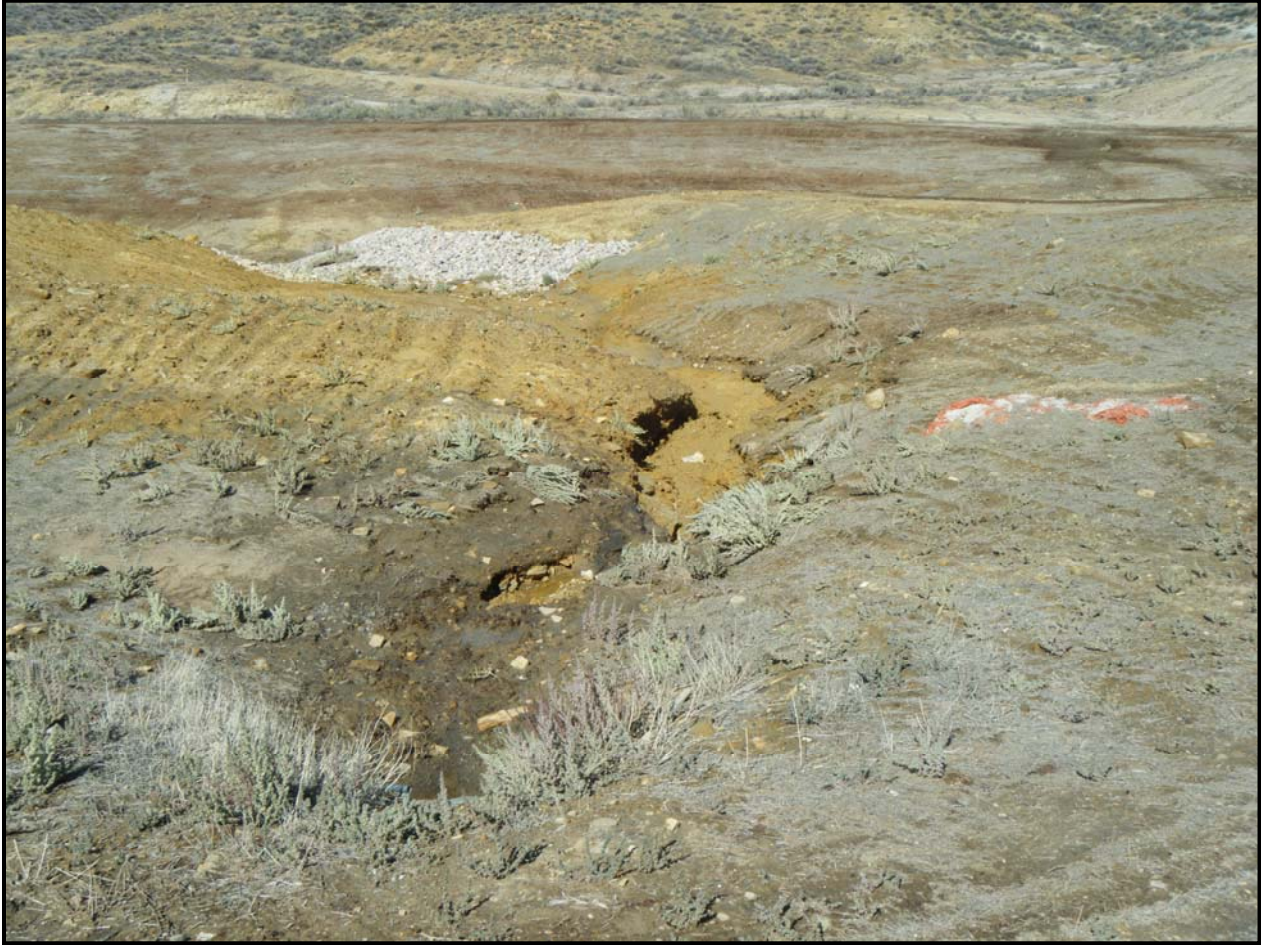
The tributary channels performed worse overall than the main drainages, with five requiring extension of rock structures and/or channel reinforcement. These tributaries included L1 and R3, feeding into the Upper Main Drainage as well as L1, L2, and L4 tributaries draining into the Lower Main Drainage (see as-built drawing in Figure A-4.1 within Appendix A4.2). The tributary channels were steep, and were initially protected with partial rock structures as it was clear that high shears would be experienced on these short steep channels. However, the armored sections were not long enough, and in most cases the channels exiting the riprap structures at the mouth of the tributary had become incised greater than 18 inches and the rock structures were becoming filled with sediment. In order to address these issues, the channels were widened and reinforced with the rock structures extended to protect the channel bottom.

Figure 23: Lionkol Upper Main Drainage: Tributary L1 Failure Upstream of Rock Structure.

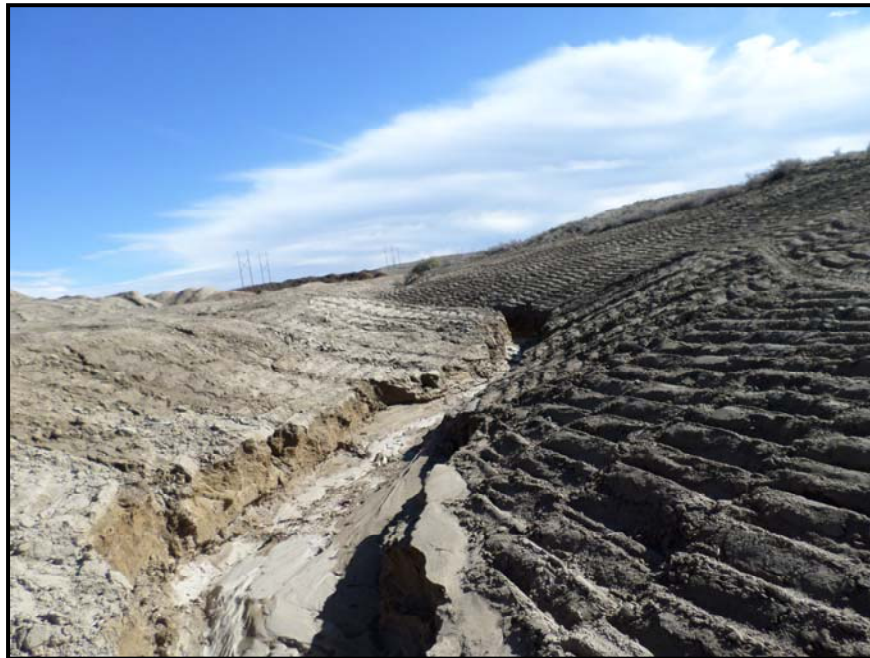
The Lionkol West project was recently completed at the time of this report. Therefore, data on the finished performance of the channels was not collected on this site. However, during construction, the site experienced three separate heavy storm flows, with a return interval of between a 10-year and 25-year storm as discussed below. The flow during these events was up to three feet deep in the main channel and cut into the banks in one location up to two feet deep.

Figure 26: Lionkol West Drainage Upper Main During Construction, Channel Failure

Erosion damage from the storm required the contractor to refinish sections of the channel. The storms provided a real world test of the various channels while an engineer was onsite to observe. Because the multiple storm events were of similar magnitudes (0.23 to 0.5 inches per 24 hours), it was possible to see how the repairs performed and make changes to the repair strategy where necessary.

A few areas highlighted by the storm flows needed significant repairs during construction. One such area was the channel exiting the box culvert underneath the roadway between the upper easternmost portion and the central portion of the main channel (see Appendix A5.3 for as-built figures). This section of the channel developed a 1-foot-deep scour hole downstream of the box culvert. In the upper area of the main channel near the box culvert, a telephone pole required a reworking of the original channel design. The channel incised nearly a foot in this area. Near the head of the channel in the upper section, a 2-foot headcut developed that required repair.

Smaller repairs in the channels consisted primarily of using the dozer to collapse cut banks and widen the channel bottom. The large headcut in the upper portion of the main channel was repaired by replacing the eroded material, to maintain a stable grade. Below the box culvert, a concrete apron was poured to dissipate the energy from the flow, and a rock structure was installed at the end of the apron to prevent damage to the channel.

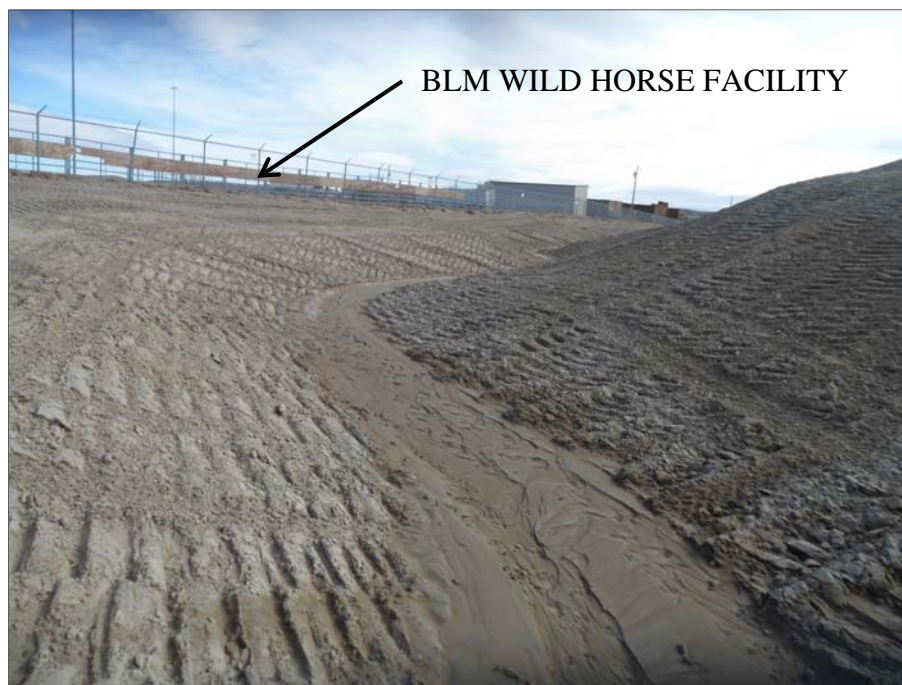
Shortly after the last storm event in September 2013, high water marks were identified and marked for survey, just upstream of the box culvert over Lionkol Road. A channel survey was completed to estimate the peak discharge and evaluate the frequency of the event.

Figure 27: Lionkol West Channel Following Heavy Fall Precipitation
