ADVANCEMENTS IN GEOMORPHIC MINE RECLAMATION DESIGN APPROACH

WYOMING ABANDONED MINE LAND PROJECT 17H-2B LIONKOL COAL MINING DISTRICT SWEETWATER COUNTY, WYOMING

Geomorphic Reclamation on the Lionkol Project

June 2014

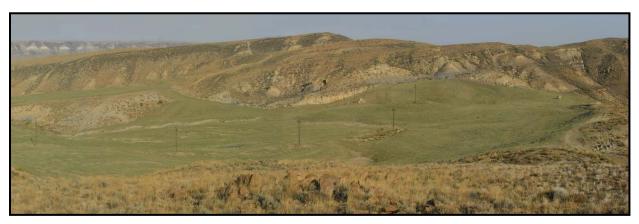
Figure 6: Reliance No. 11 North Following Revegetation

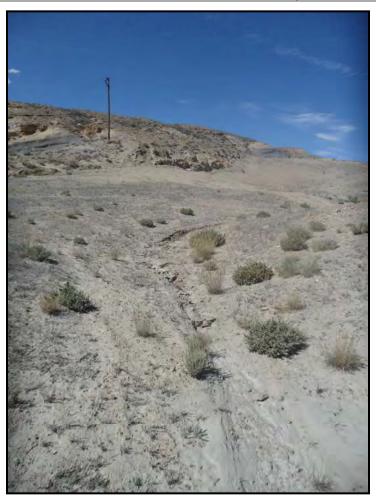
- All of the geomorphic channels were found to have stable uplands.
- Meandering channels exhibited repetitive phases of cutting and deposition 50 feet long by 6 inches in depth, consistent with natural channel behavior in the area.
- Pilot channels 8 to 10 inches deep were created by focused flows, typically related to adjustment of the channel bed to inconsistencies in the channel grading and/or downstream of confluences with higher combined volumes of flow.
- Moderate armoring and stabilization of the pilot channels with 4-8 inch diameter rock was occurring where spoil materials allowed.
- Vegetation was successfully established in the majority of the armored channels.
- Minimal amounts of coal or other undesirable materials were being exposed and redistributed.

The performance of the geomorphic channels in Reliance No.11 North is consistent with natural channel behavior, which is the goal of the project.

Figure 8: Reliance No. 11 North R1-3: Looking upstream at Properly Performing Channel

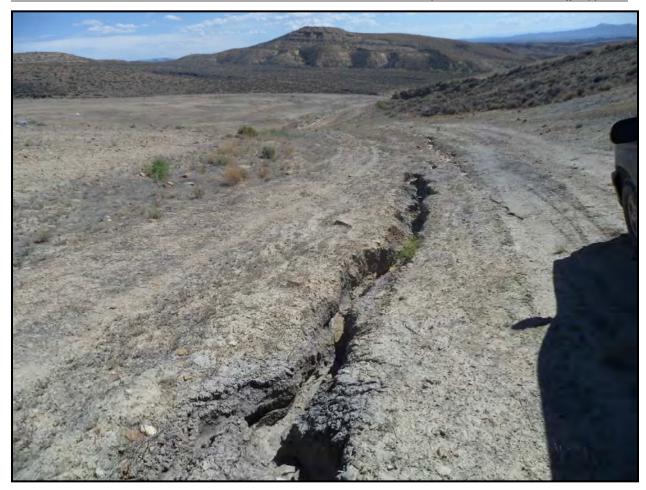
A single failure, requiring repair, occurred within the traditional channels located west of the North Main Pond, Traditional Channel Main and Traditional Channel L1 (see as-built drawing in Figure A-2.2 in Appendix A2.2). The Main channel was constructed along the boundary of the reclaimed area following the alignment and grades of a pre-existing drainage beside a spoils pile. Steep channel gradient (>10%) and the 22 acre contributing drainage basin caused failure of the channel, resulting in a 50 feet long by 2 to 2.5 feet deep pilot channel forming upstream of the confluence between the Traditional Channel Main and the Traditional Channel L1, exposing coal and shale. Erosion diminished and ended in an area of deposition 30 feet downstream of the confluence.

Figure 9: Traditional Channel Main: Failure in August 2013, Looking Downstream

Repairs were made to the traditional channels on October 24th, 2013. Wheel rolling the pilot channel with a scraper was performed to restore a widened channel flow-line and provide compaction. In the event that the channel continues to erode following these repairs, future redesign of the drainage as an "A-channel" rather than a traditional channel is the recommended solution. In general, the geomorphic channels designed using NR provided superior performance compared to the traditional channels in Reliance No. 11 North Basins.

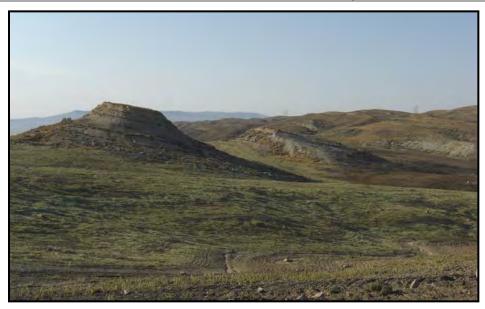
The physical properties of the South Spoils basin are shown in Table 2.22 in Appendix A2.2. The total basin area for the South Spoils area is 12.4 acres. Total relief in the south basin is very high and steep, with an average channel relief of 108 feet and grades in excess of 8%. The design runoff parameters are shown in Table 2.23. Maximum Shields shear stresses well in excess of the stability criteria are shown on the runoff parameters tabulation. However, it was anticipated that this area would be excavated to a native bedrock surface, and as such would be stable with steeper gradients than are permissible on loose, unconsolidated spoils and backfill materials. As a result, no excessive erosion has been observed in this area.

Figure 11: Reliance No. 11 South Site Incorporation of Native Formations into Reclaimed Surface

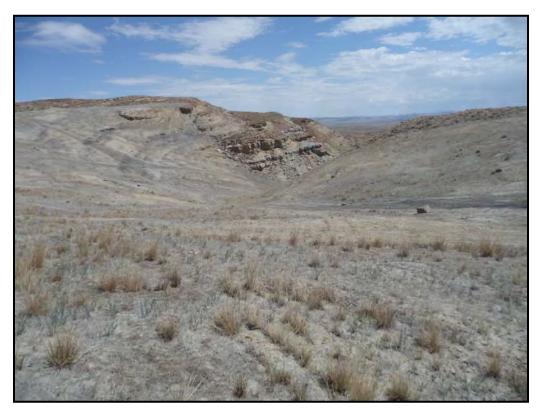
Geomorphic channels within the South Spoils area were found to have been damaged by vehicles, as they had been used as roadways following completion of reclamation. However, the channels were still performing well. Natural bedding of bedrock was observed to be anchoring the channel flow-lines and no unnatural level of erosion was observed to be occurring at the time of inventory, despite the post-reclamation damage to the channels by off-road vehicles.

Figure 12: Reliance No. 11 South: South Spoils. Looking Downstream into Main-L1

The most active channel pilot formation in the area occurred within a 20 foot channel segment within the South Main geomorphic channel, immediately upstream of the Main-L1R1 confluence (see Figures A-2.3 and A-2.4 in Appendix A2.3 for as-built drawings). Following multiple unseasonably heavy rain events during October 2013, the site was revisited and the original 18 inch deep pilot channel had repaired itself. However, a sub-ridge failure upstream of the same confluence on L1R1 drainage had developed and was cutting 10 to 18 inches deep along a 150 foot long segment of the channel. A repair of the L1R1 channel segment was performed on October 29th, 2013 by widening the flow-line and reinforcing the channel banks using a dozer. This repair is expected to decrease the linear flow rate within the channel and reduce erosion to an acceptable level. No other repairs were deemed necessary on the site.
