F. EXAMPLE PROJECTS WHICH BEST ILLUSTRATE PROPOSED TEAM'S QUALIFICATIONS FOR THIS CONTRACT

- A. EXAMPLE PROJECT KEY NUMBER: **AML 17.32 Statewide Contracts**
- B. TITLE AND LOCATION (*City and State*): **Statewide Wyoming**
- C. YEAR COMPLETED - PROFESSIONAL SERVICES: **Ongoing**
- D. YEAR COMPLETED - CONSTRUCTION (*If applicable*): **Ongoing**
- 23a. PROJECT OWNER'S INFORMATION - PROJECT OWNER: **Wyoming AML**
- 23b. PROJECT OWNER'S INFORMATION - POINT OF CONTACT NAME: **George Boulter, AML Project Officer**
- 23c. PROJECT OWNER'S INFORMATION - POINT OF CONTACT TELEPHONE NUMBER: **307 777-6145**
24. BRIEF DESCRIPTION OF PROJECT AND RELEVANCE TO THIS CONTRACT (*Include scope, size, and cost*): **Follows**
25. FIRMS FROM SECTION INVOLVED WITH THIS PROJECT

(1) FIRM NAME	(2) FIRM LOCATION (<i>City and State</i>)	(3) ROLE
BRS Inc.	Riverton, WY	Site Investigation, Design, CM

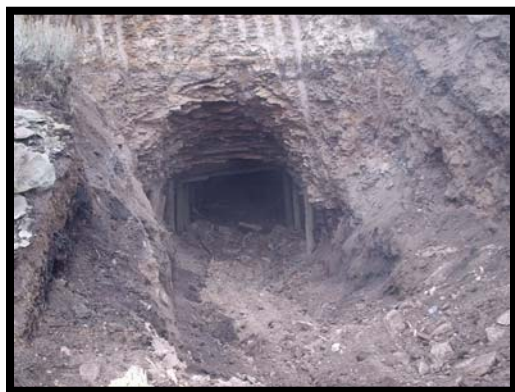
Excavated Portal (to competent roof and back)

The Kent mine consisted of 7 open and 6 covered portals at the base of a ridge adjacent to an ephemeral drainage. Coal slack and mine waste had been dumped into the drainage creating erosional instability and off-site environmental impacts. The BLM participated in the cost of construction due to the drainage impacts and provided all site clearance work. As part of the project, certain historic features were to be preserved. BRS worked with AML's designated archeologist to accomplish this requirement and in the course of construction encountered and preserved an additional feature not previously inventoried. This project included both mine closures and removal and disposal of unsuitable mine waste.

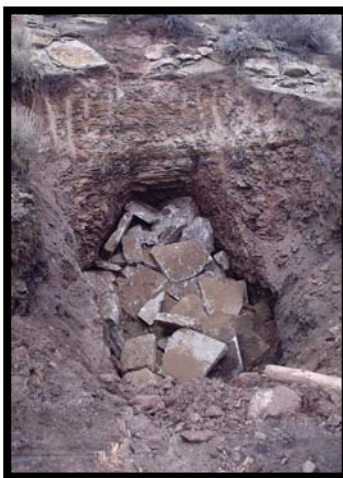
Bulkhead Closure

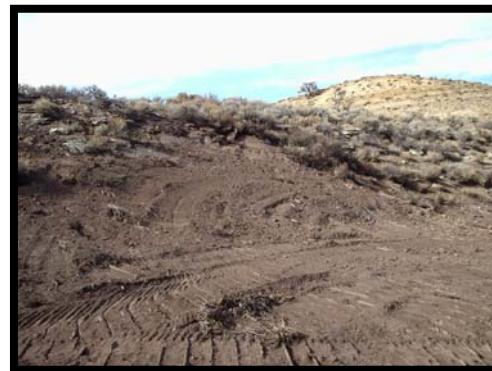
Finish Grading

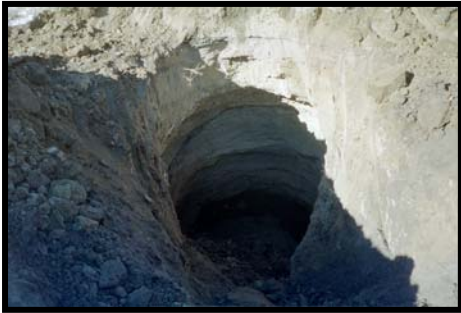
The Burnright site consisted of one large open subsidence, 2 covered portals and 3 shallow subsidence features. Site work consisted of over-excavation of the open subsidence feature and when tested the portals and one of the closed subsidence features opened as well. Excavation proceeded to a competent roof and back. Any remaining openings were closed with local rock material to establish a

Open Subsidence

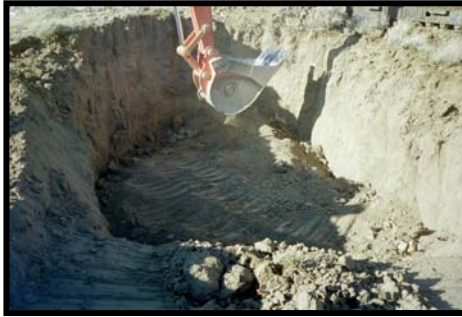
Compaction of Backfill

bulkhead. Backfill was completed with local material, compacted and mounded over the feature establishing positive drainage away from the site. Topsoil was salvaged and replaced. The site was broadcast seeded.

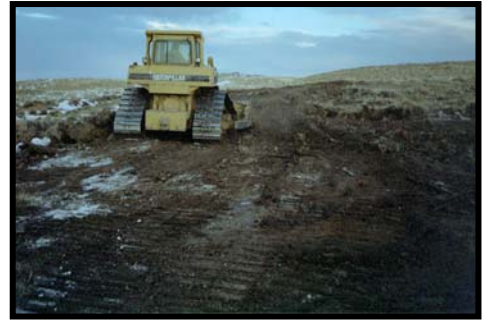
Topsoil Replacement/Grading

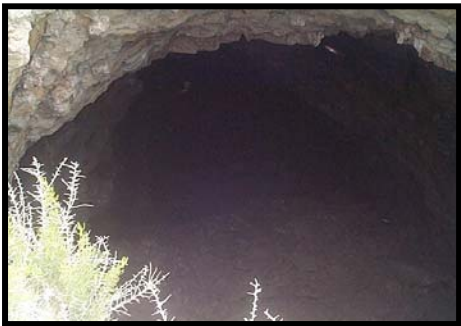
The Monarch subsidence occurred along a shallow portion of the main haulage of the Old Monarch mine. The initial surface expression of subsidence included 4 separate open or partially open subsidence features. The features were excavated revealing interconnection of the workings and in the course of work two additional features were located and closed. In total 1 acre was affected. Following excavation, the subsidence features were backfilled with waste scoria from a local quarry to establish a bulkhead and site backfill was completed with compacted local fill materials prior to replacement of topsoil and reseeded.

Open Subsidence

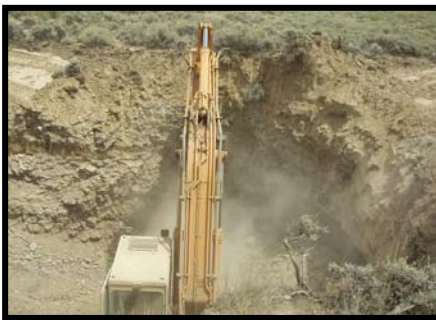
Excavation

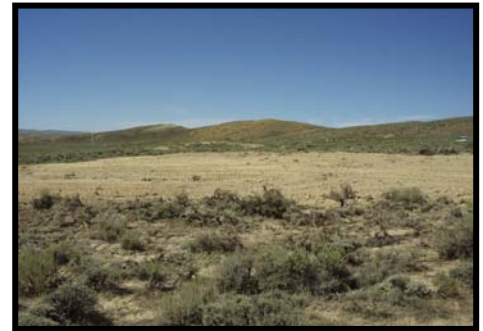
Final Graded Surface

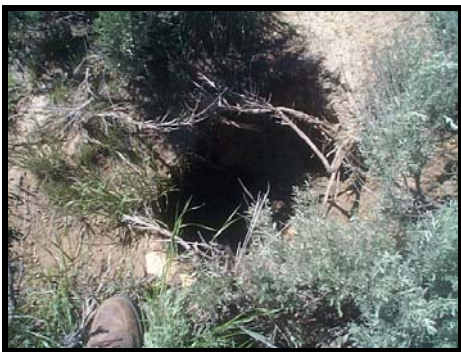
During the investigation phase of the Hanna No.4 project, a large open subsidence feature was located in the field by BRS personnel. Due to its immediate proximity to Hanna the site feature was addressed by mass excavation. The surface expression of subsidence occurred at the intersection of a main haulage tunnel and two perpendicular lateral tunnels. The tunnels were collapsed to the extent possible, then backfilled with compacted local materials. Permanent bulkheads were not established as future project work will re-affect this area.

Open Subsidence >35 Feet Deep

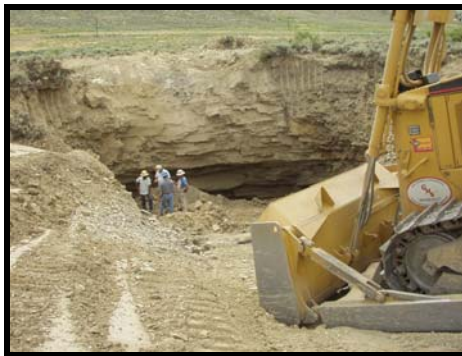
Excavation in progress

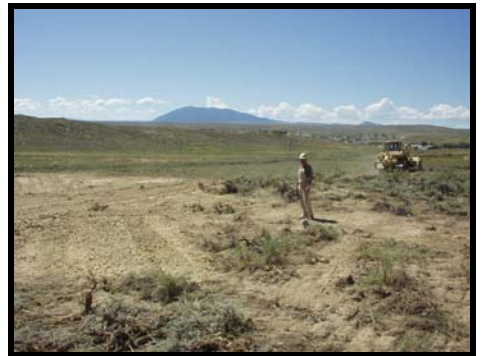
Finished Grade
