# 3.0 Reliance No. 3 and Lionkol Main Pits: Design Summary

The AML Project 17H-2B-II, Reliance No. 3 and Lionkol Main Pits reclamation area addressed two separate coal mine areas primarily using NR design software with a minimal amount of traditional reclamation techniques. The project areas are shown in Figure A-1.2 in Appendix A1.

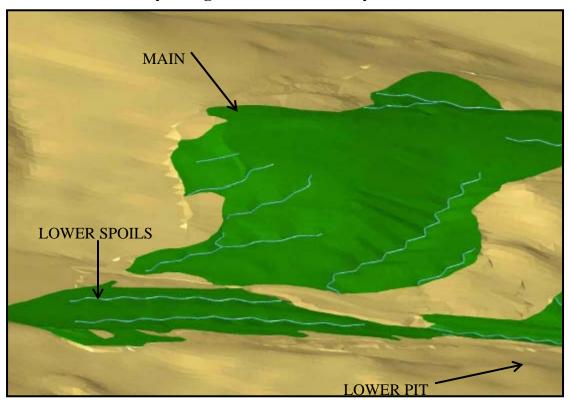
Figure 19: Lionkol North Main: Channel failure incised to bedrock

The erosion of the North Main channel resulted from several factors. In addition to having high gradients and the largest basin area in excess of 13 acres, the west facing slope of the North Main channel had the poorest re-vegetative success covering a widespread area of any Lionkol reclamation area. The lack of vegetation and lack of infiltration of rainwater into the poor soil of the slope increased runoff and caused unacceptable erosion within the main drainage. To mitigate this problem, multiple hummocks and swales were constructed on the slope utilizing a dozer to trap runoff, promote moisture retention and future vegetative growth.
