4.0 AML 17H-2B-III Lionkol Drainage Reclamation Project

5.0 AML 17H-2B-IV Lionkol West Drainage Reclamation Project

LIONKOL AREA GEOMORPHIC RECLAMATION
AML PROJECT 17 H-2, 2B-II, 2B-III, & 2B-IV
SWEETWATER COUNTY WYOMING

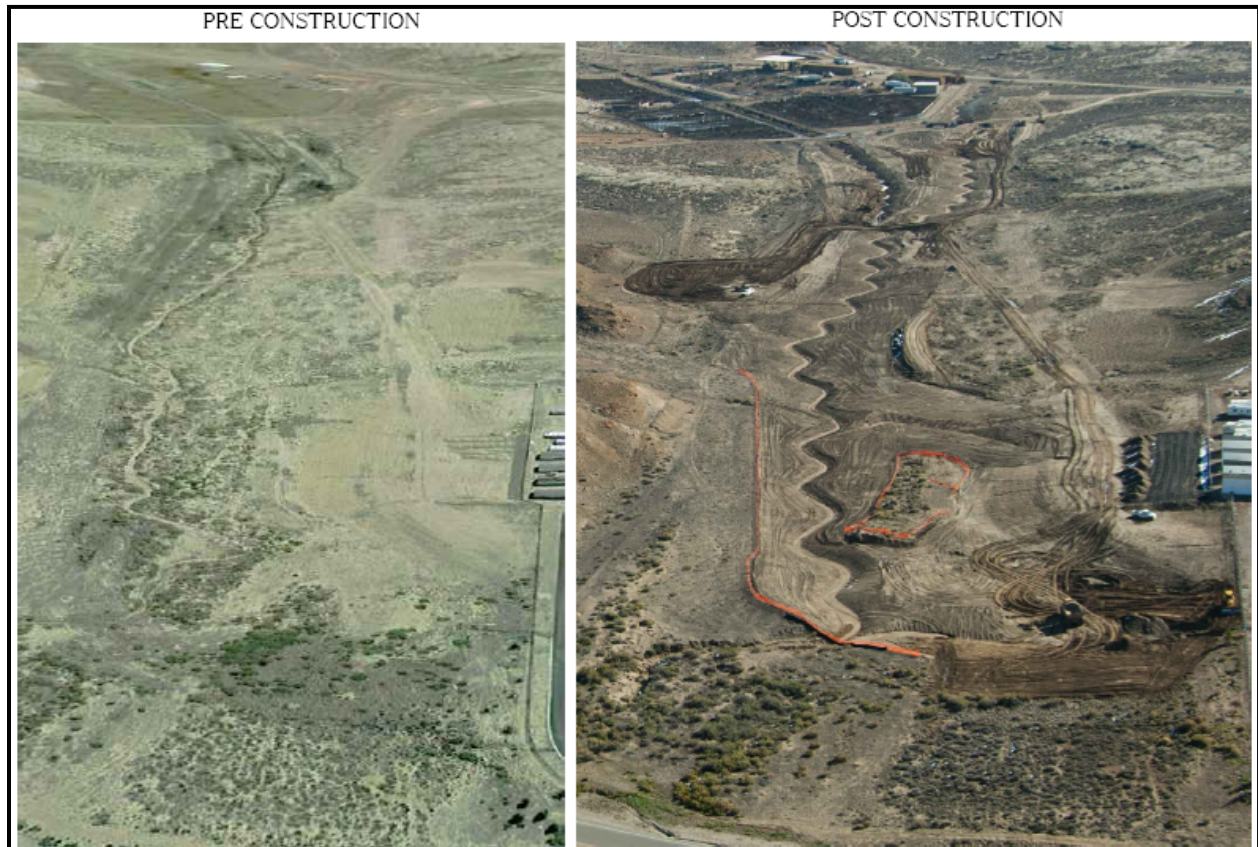
Figure 24: Before and After Photos of the Lionkol Phase 4 Project.

The large contributing drainage areas provided a challenge to designing a stable channel during Phase IV. Regional regression equations were used to estimate the contributing area runoff (Miller, 2003) as utilized in Phase III as well. This resulted in more realistic flow estimates due to the natural routing of flows, and lowered the shear stresses closer to the design criteria. Section 4.1 discusses Miller (2003) in more detail. Shear stresses on the Main channel were allowed to exceed the design criteria of 1.5 for the flood prone condition because the channel grades were designed flatter than the native grades. The channel has performed well during recent significant runoff flow events. See Section 5.2.4 the site performance evaluation.

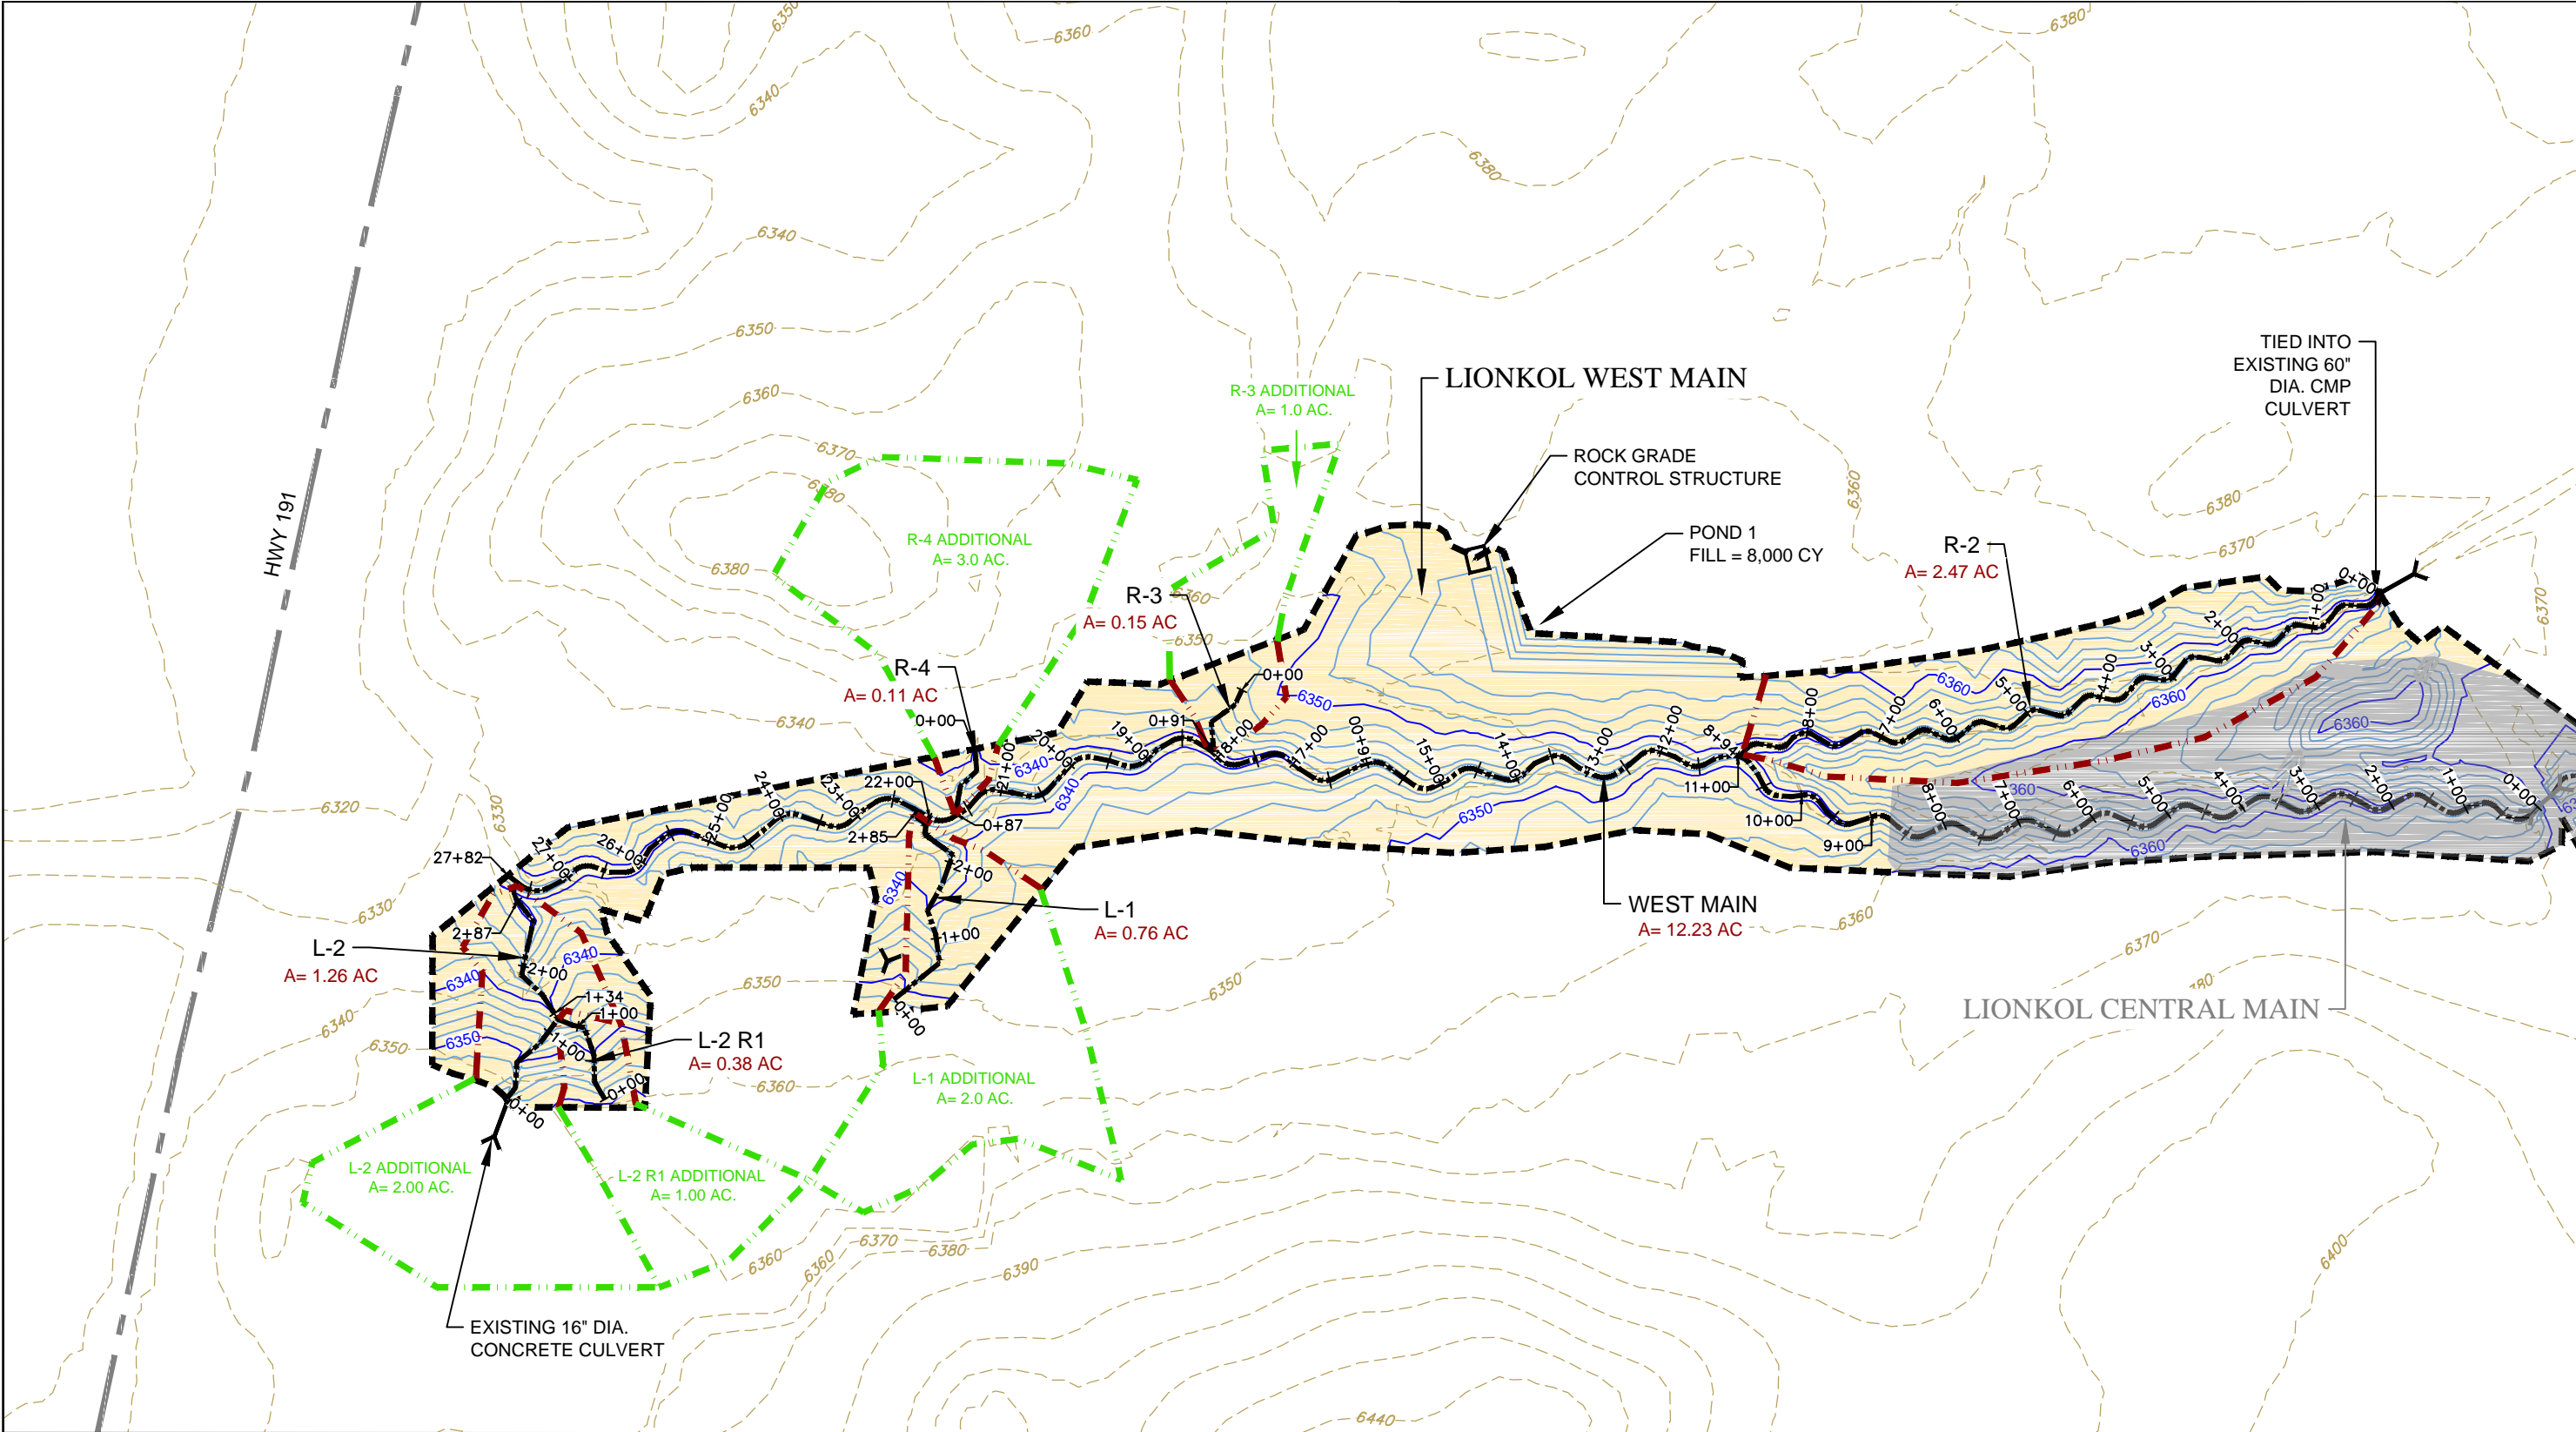
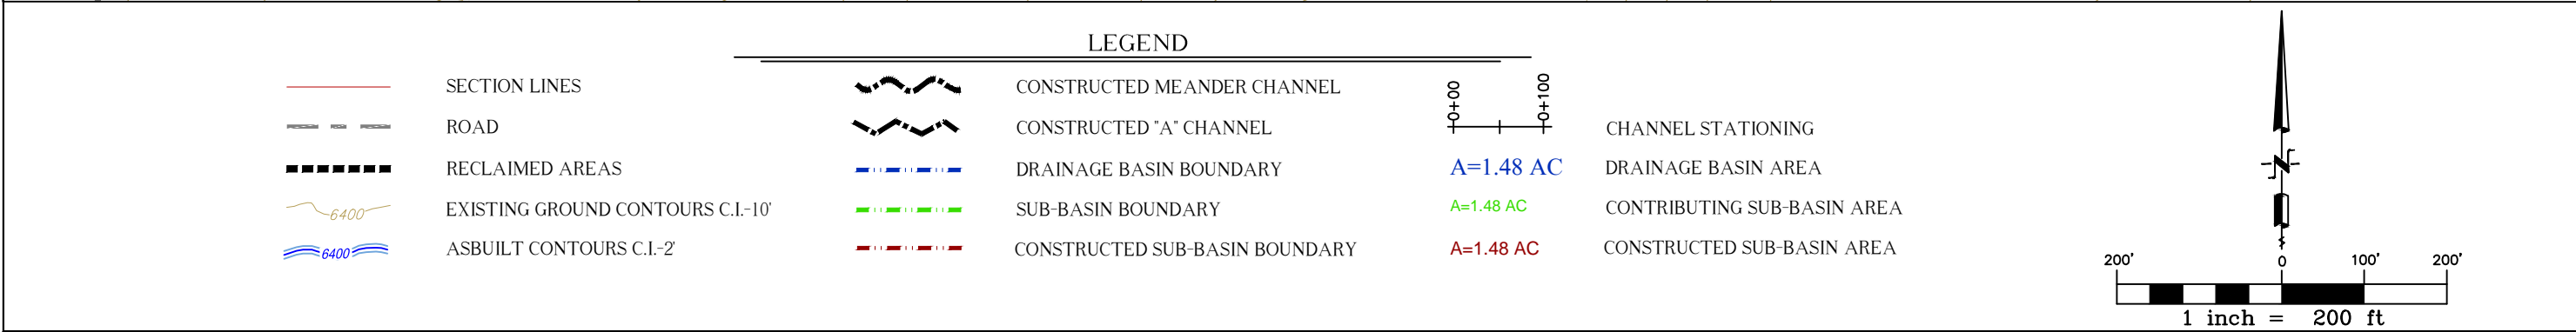
LIONKOL WEST

An “A” channel was damaged through its entire length near the BLM parking lot. This channel originated from a culvert under the BLM parking lot in the lower (western) portion of the site (see as-built drawing in Figure A-5.2 in Appendix A5.3). The channel material in this area is sandy, and it was not able to maintain the designed shape even under normal flows due to lack of cohesion of the materials. Widening the channel would have been an insufficient solution in the poor material, so the channel was lined with rock to disperse the energy of the water and protect the channel.
